# JR. HIGH RENOVATION FACILITY ANALYSIS

## GUTHRIE PUBLIC SCHOOLS

November 19, 2013

Building Name: Guthrie Jr. High

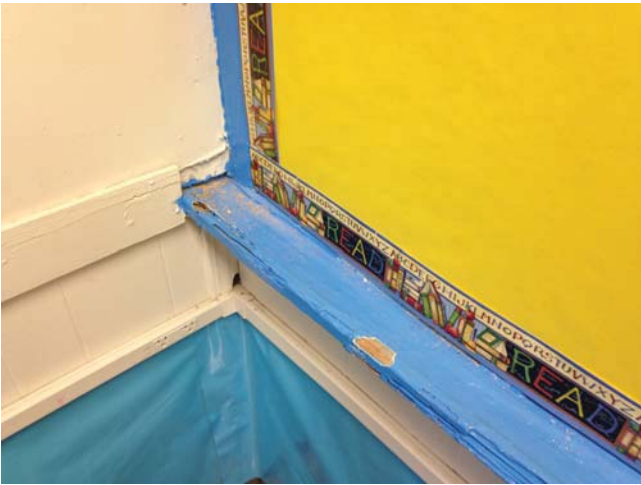
Termite Damage

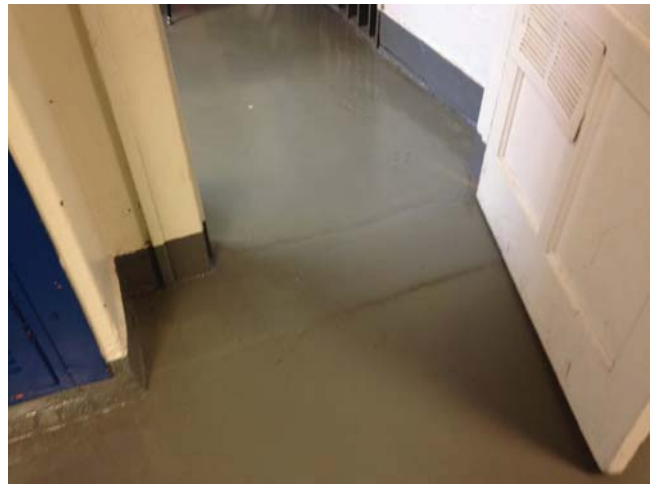
Step down into classroom

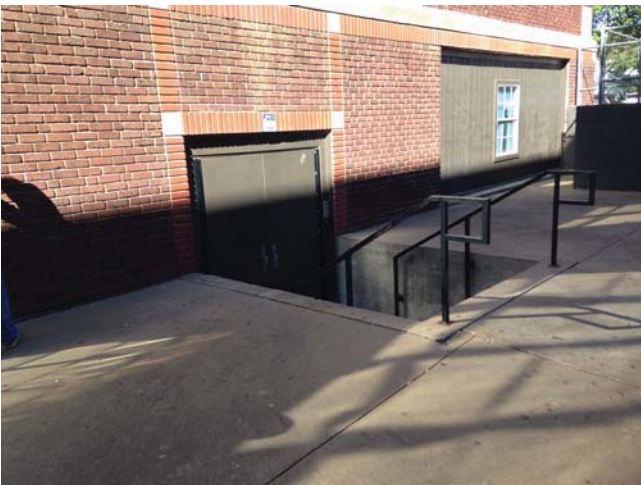
Egress below grade

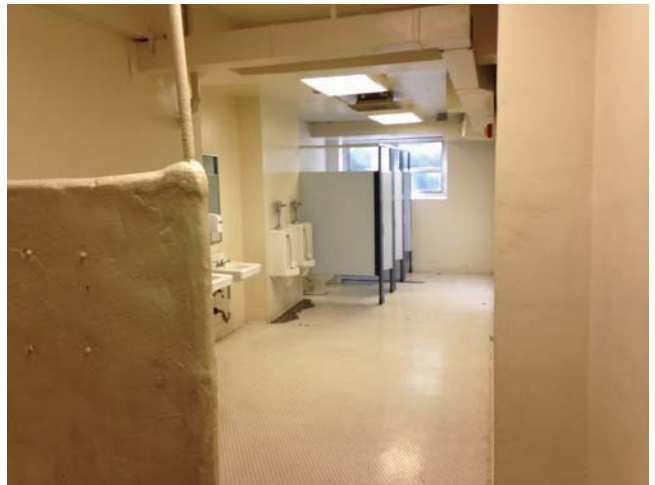
Step up into restroom—ADA upgrades

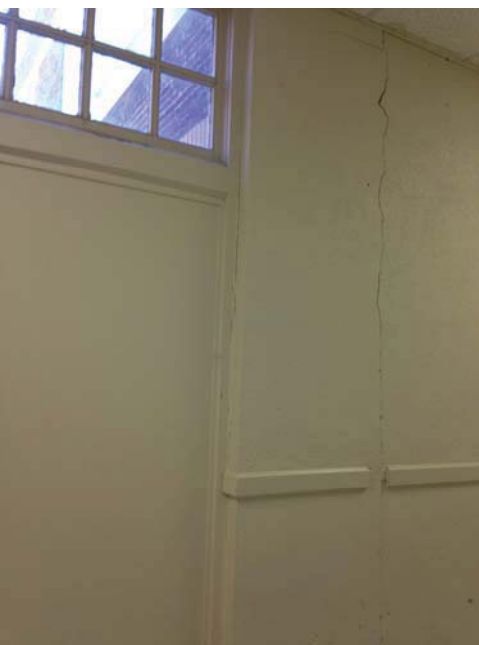
Movement at previous addition line

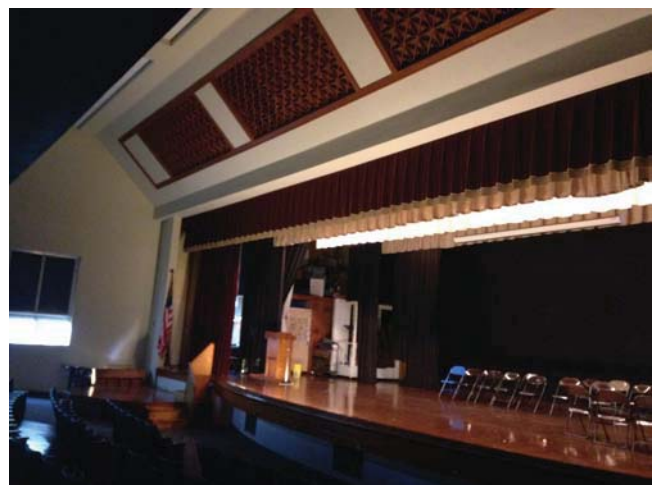
Renovate Auditorium

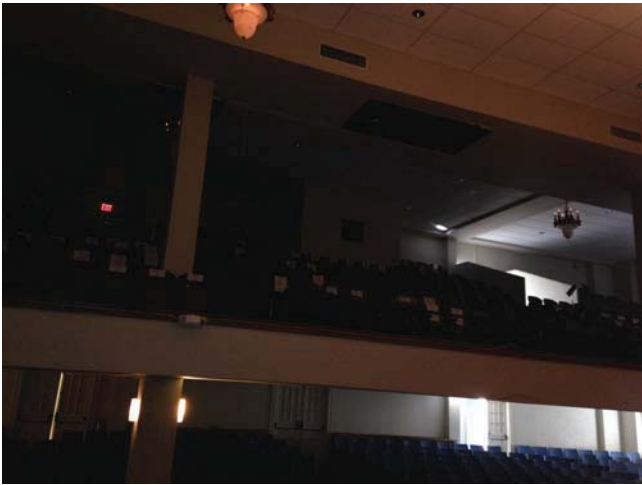
Water repair—new seating/ lighting

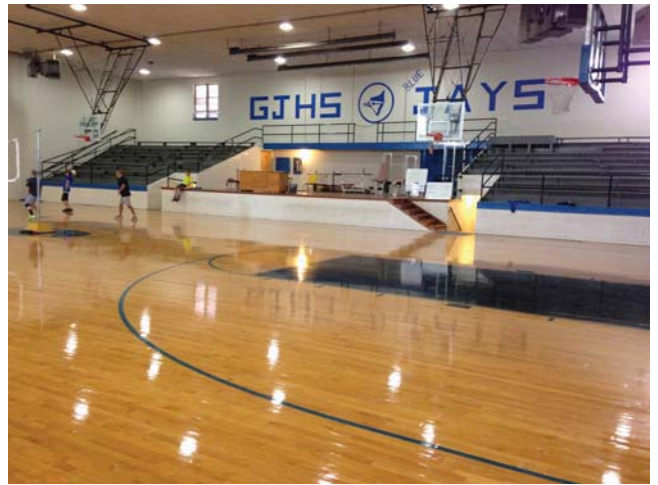
Heating/ seating/ lighting/ finishes

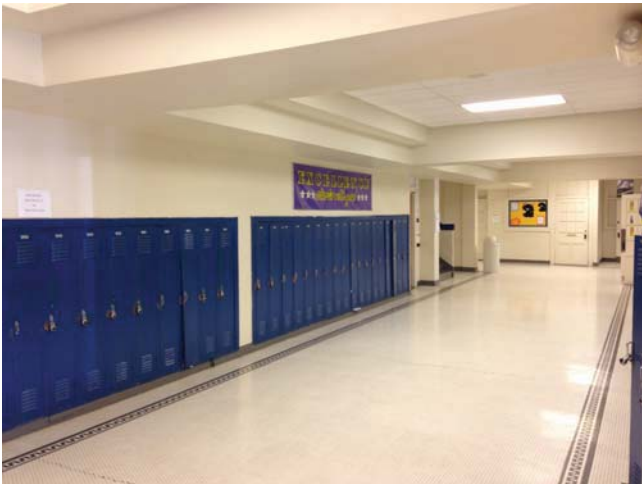
New lockers/ flooring/ finishes

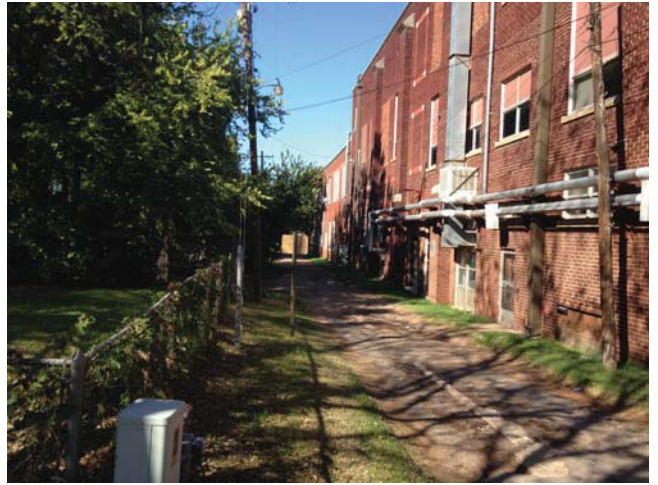
Clean up exterior utilities/ alley access

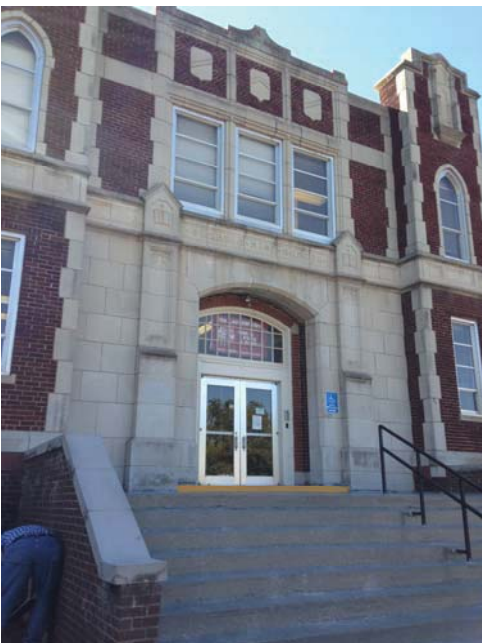
Exterior needs tuckpointing

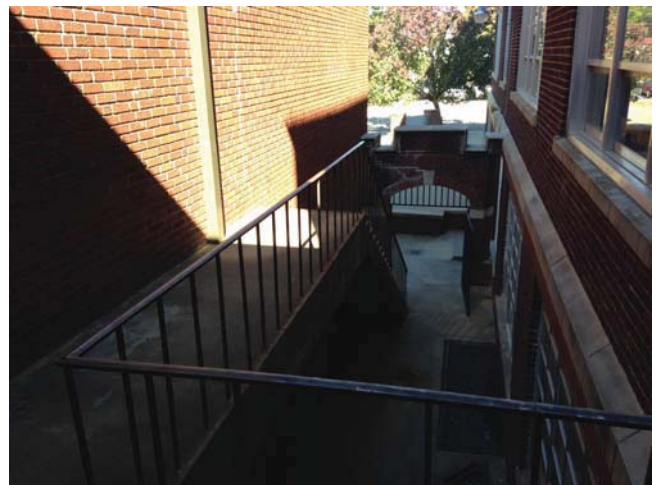
Egress stair not to code

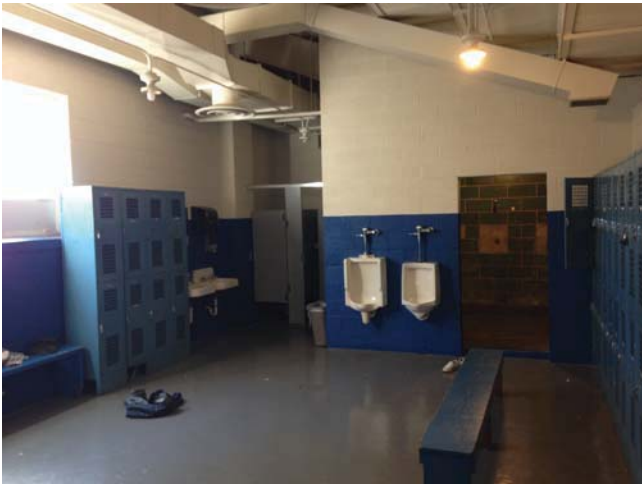
Locker rooms need full renovation

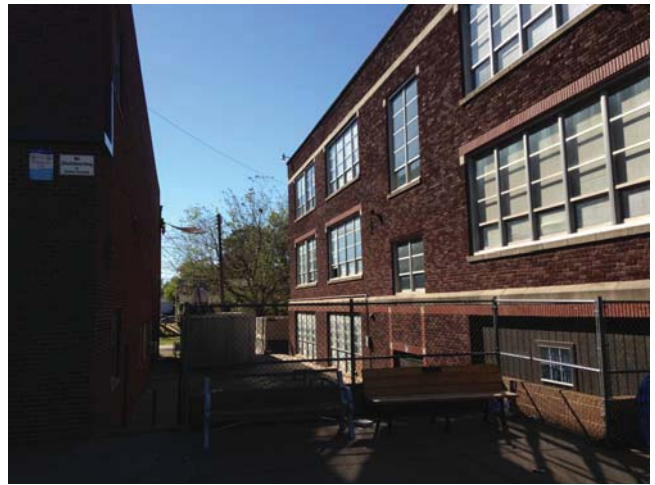
All windows should be replaced

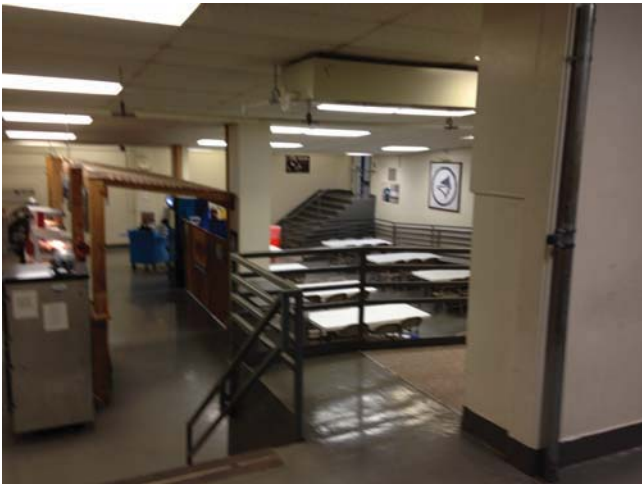
Café access difficult—poor visibility

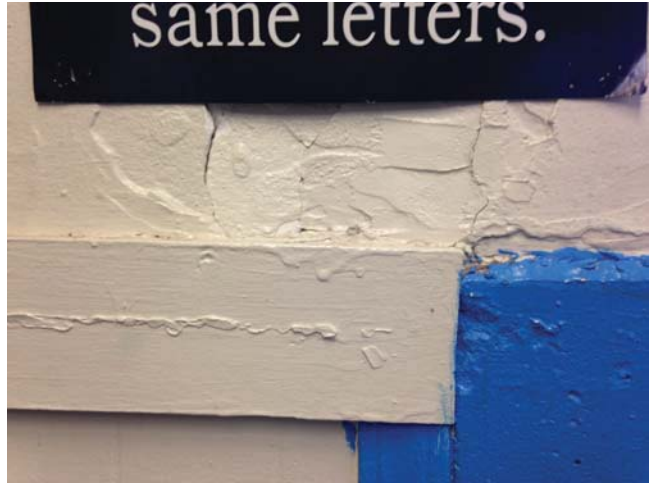
Water damage below grade

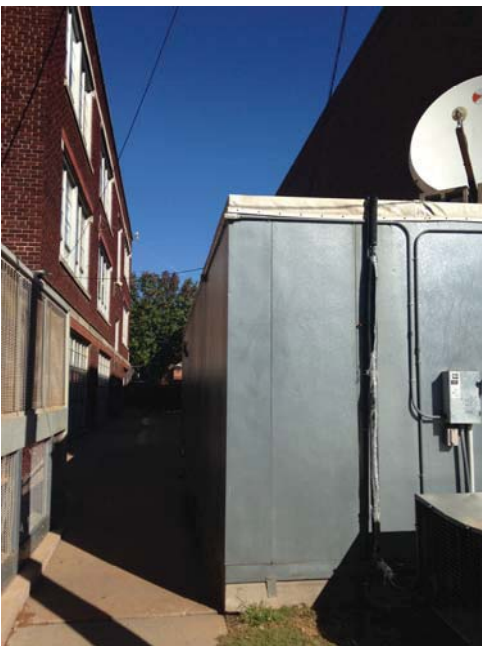
Cooler/ freezer located outside

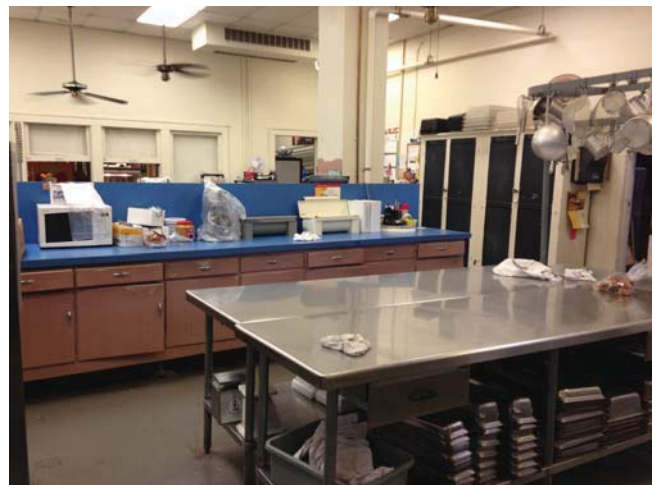
Kitchen needs reorganized/ updated

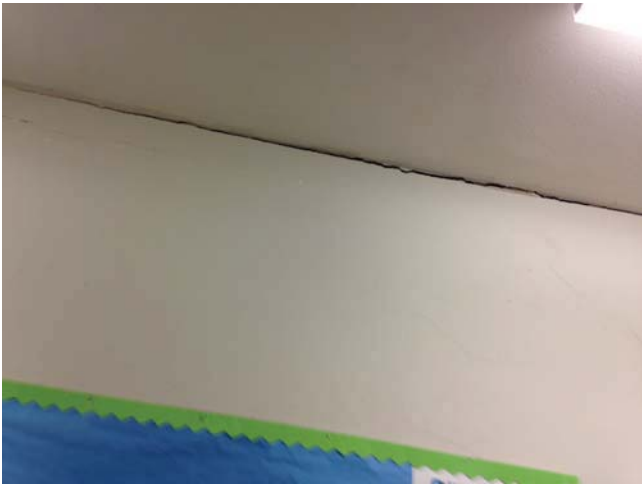
Some settling observed—easily corrected

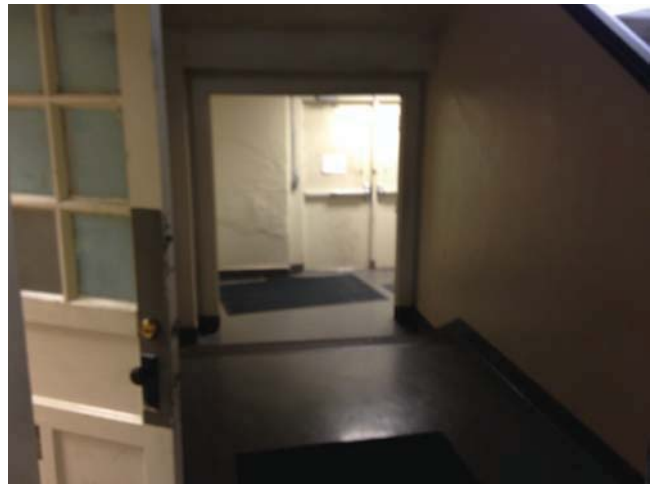
Non-accessible egress path

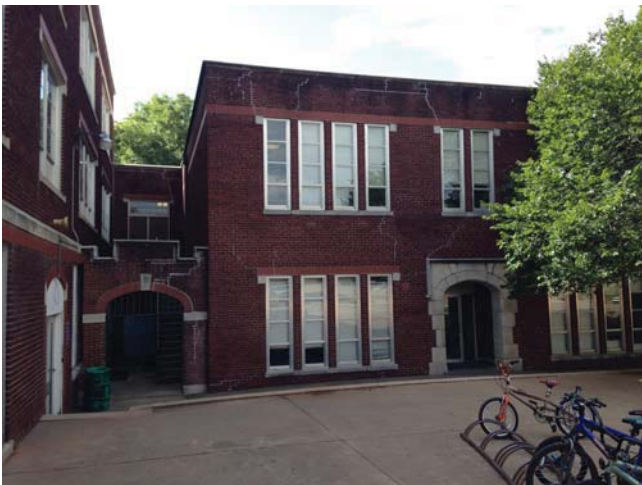
Brick needs tuckpointing

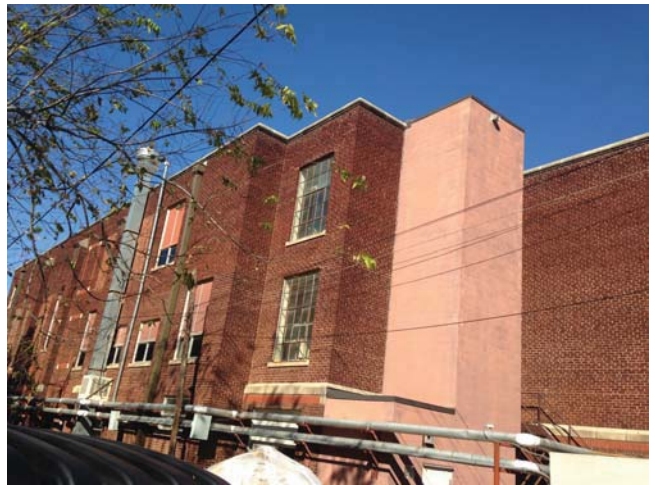
Movement at elevator—new windows

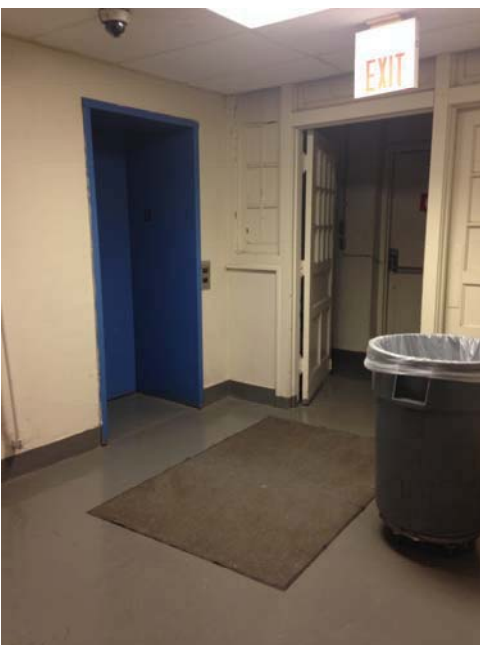
Elevator—some movement

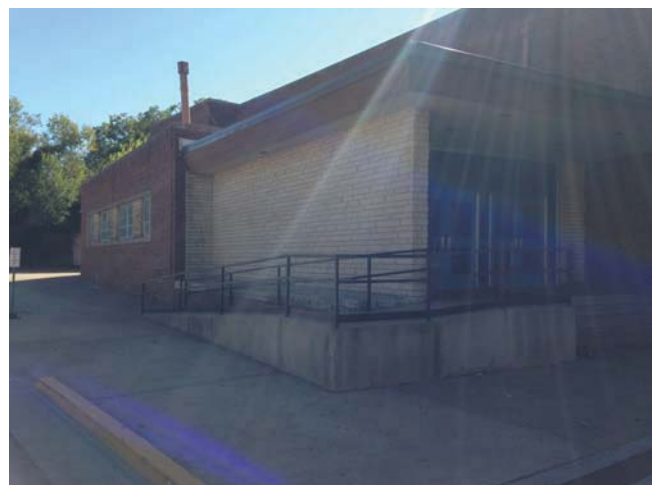
Gym exterior in better condition

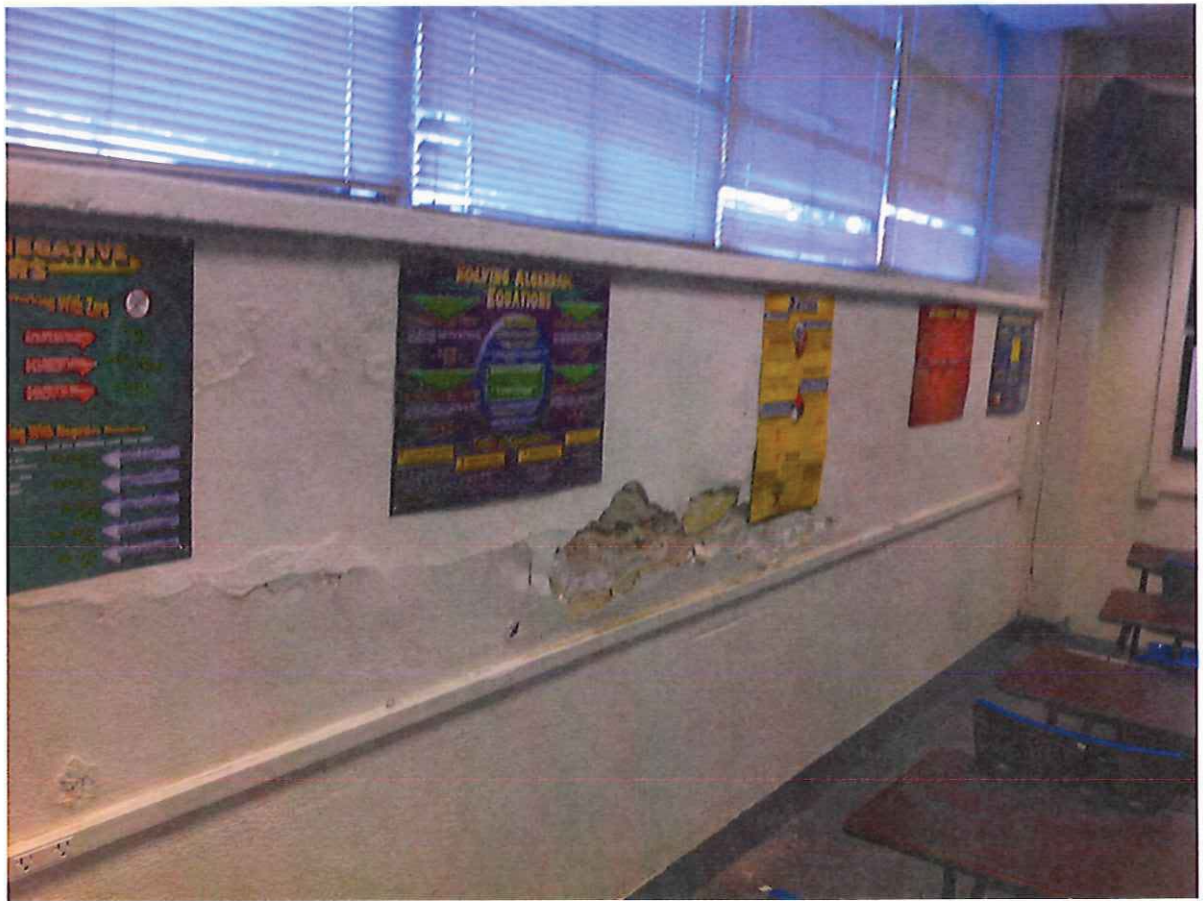
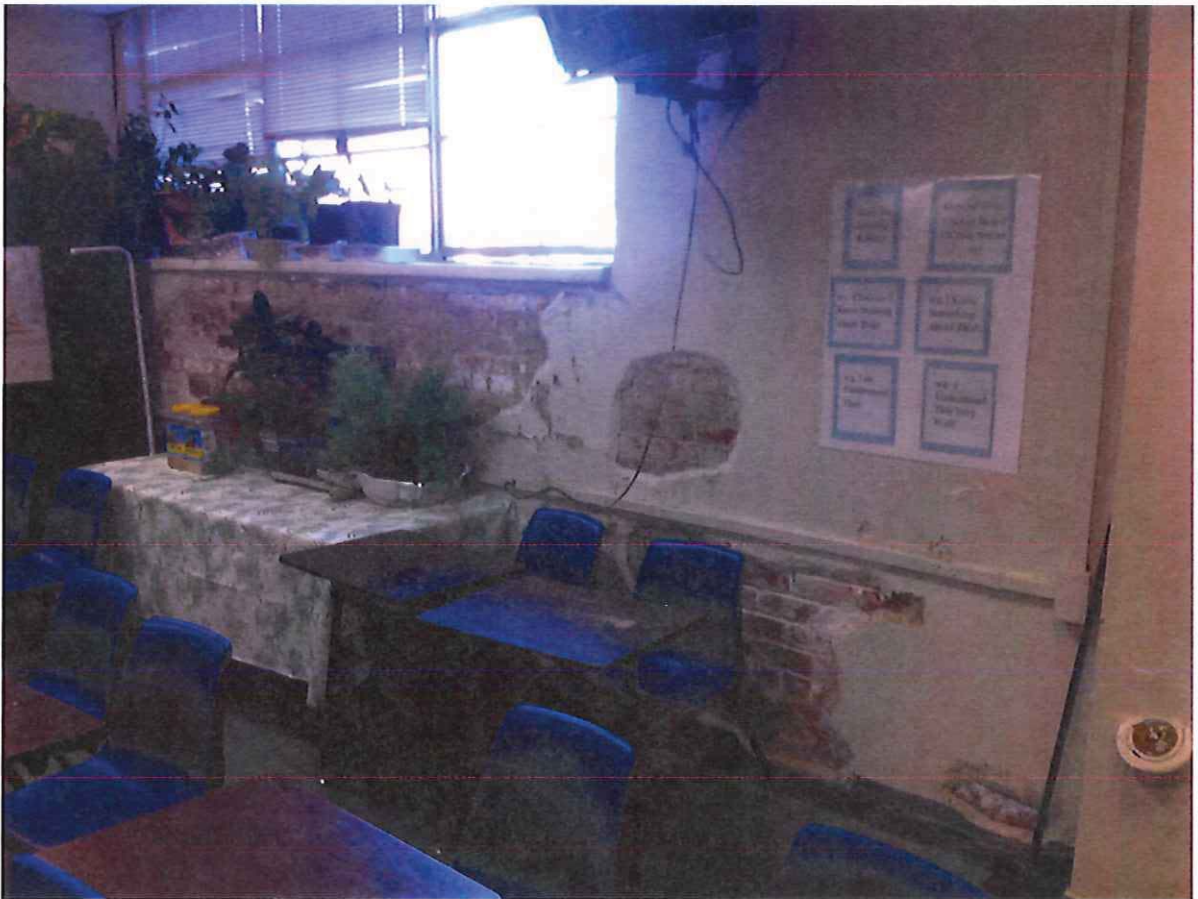
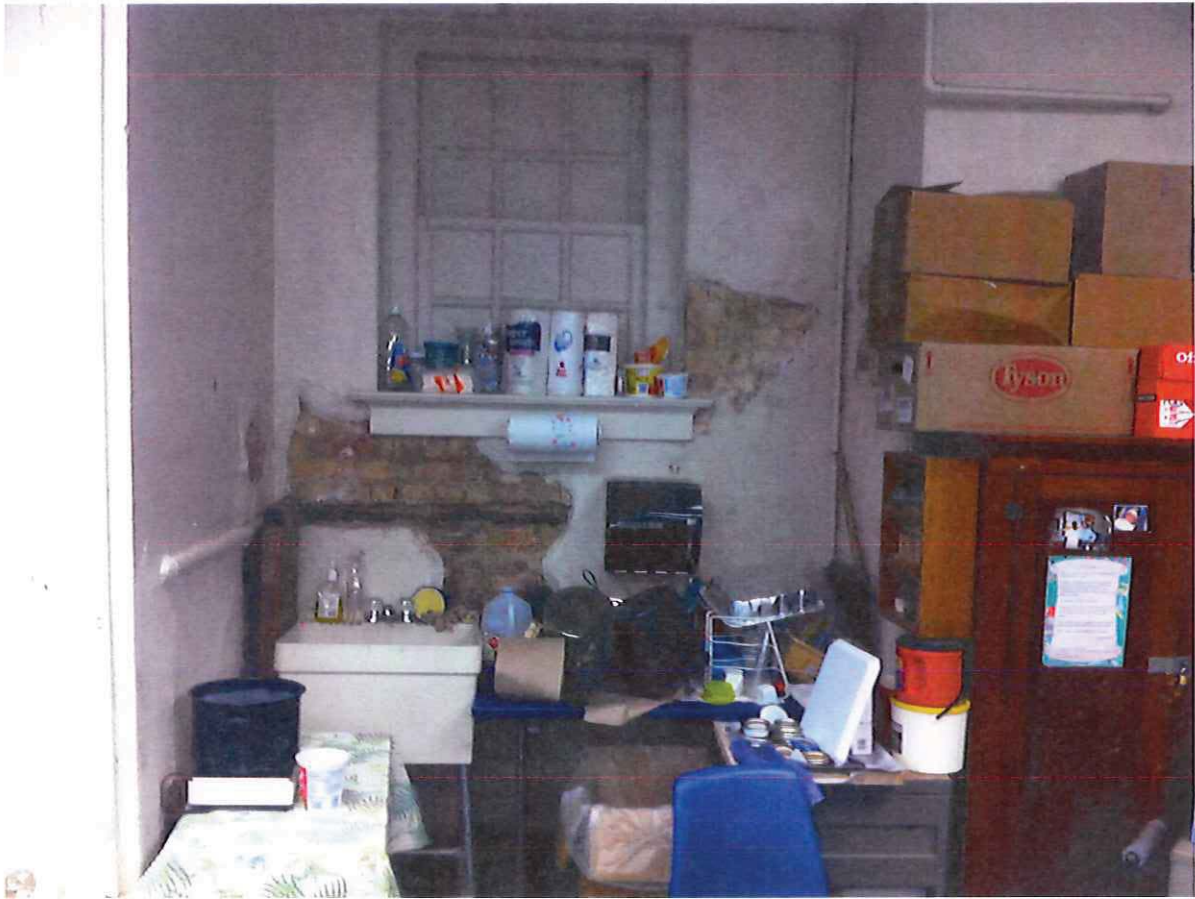
In several locations along the north wall at the first level, damage to the plaster finish and substrate has been caused by water infiltration. Pictures 1, 2 and 3.

Picture #1 – Water Damage at First Level

Picture #2 – Water Damage at First Level

Picture #3 – Water Damage at First Level

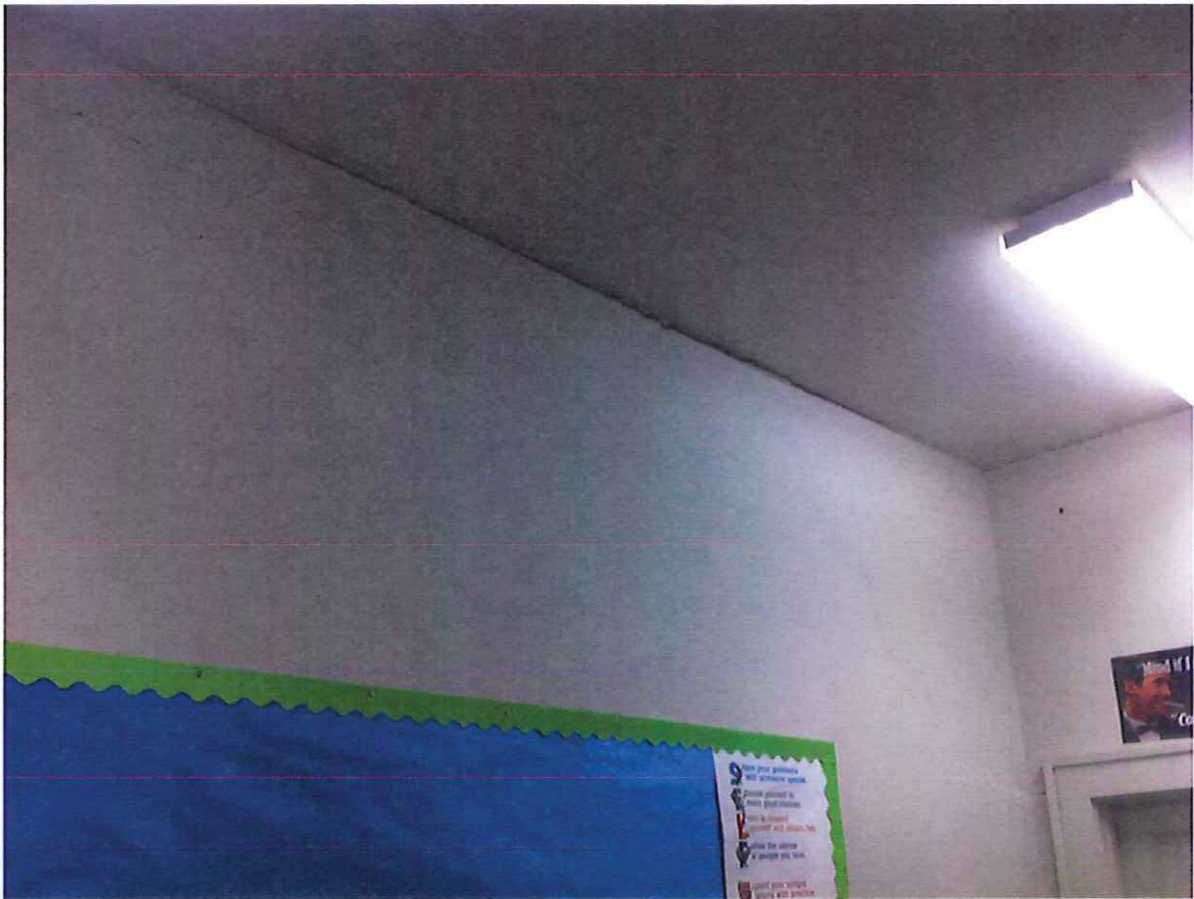
Picture #4 – Settlement Crack Between Wall and Ceiling in Storage Room

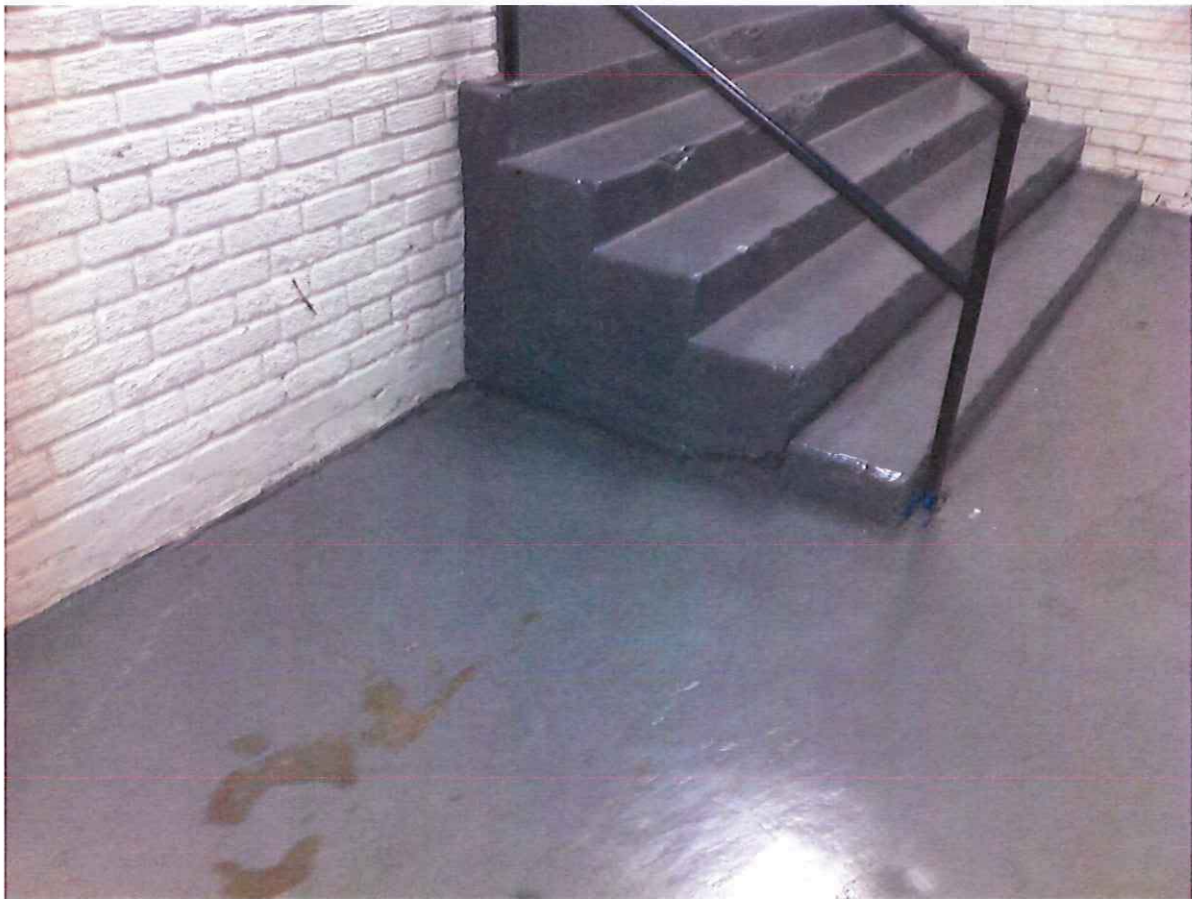
Picture #5 – Settlement at Base of Stairs to Shop Classroom

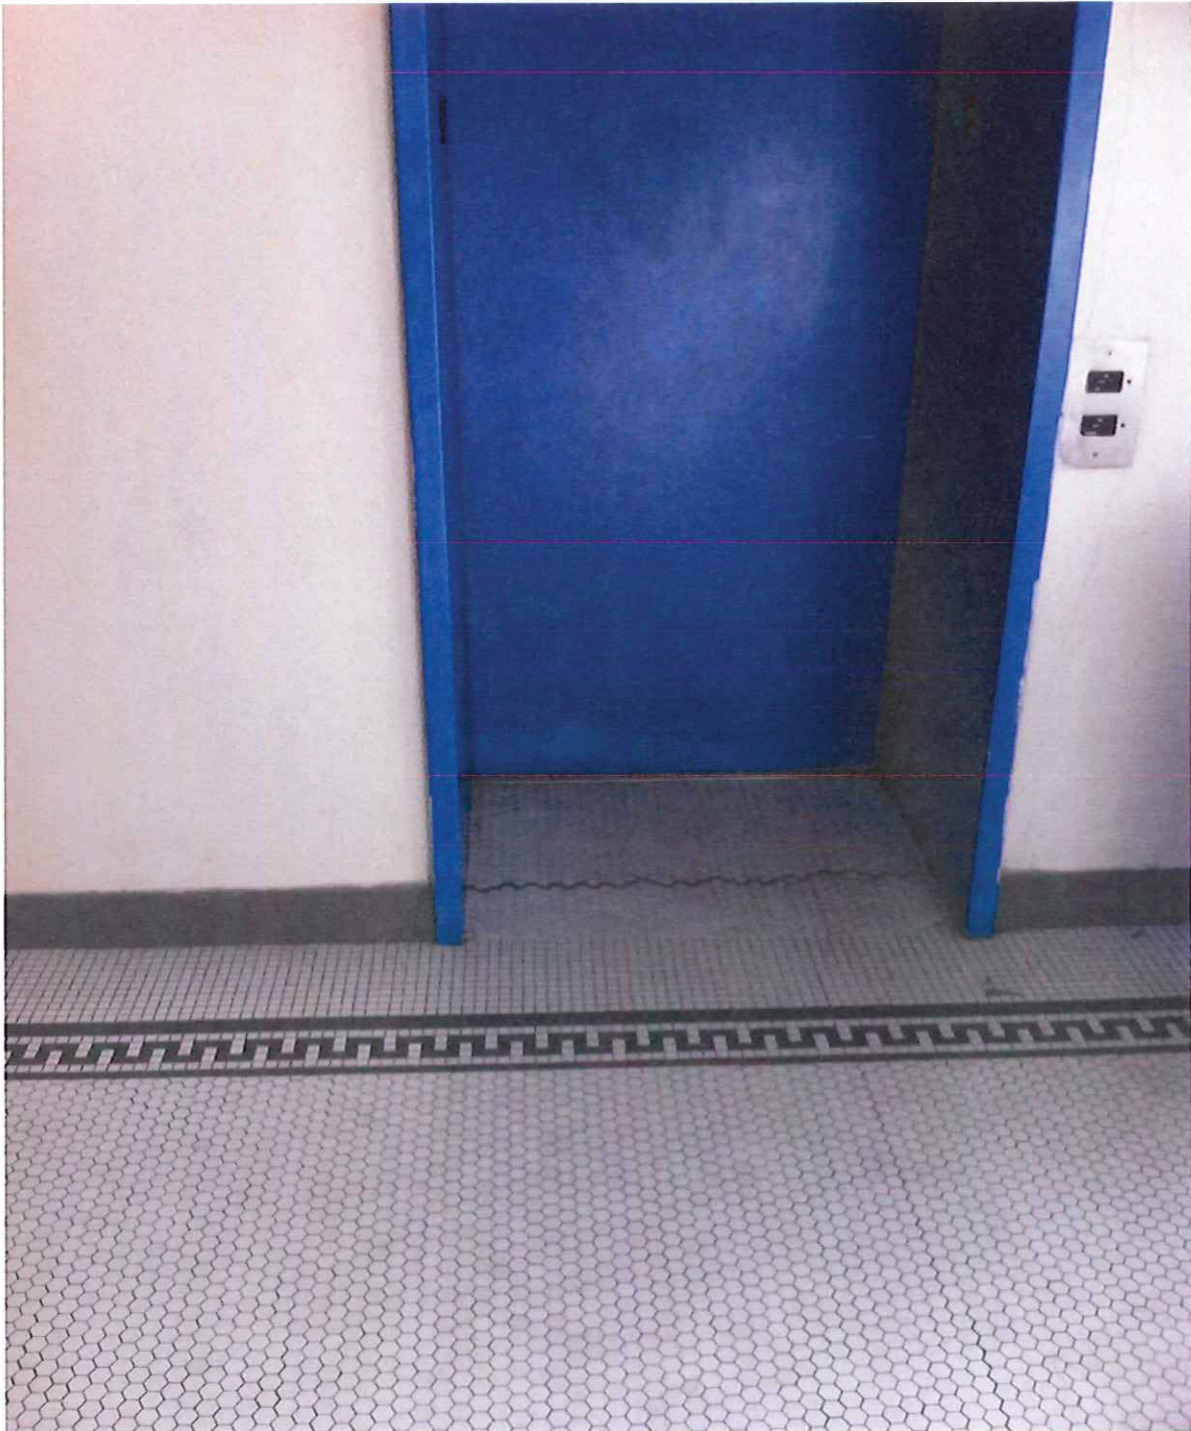
Picture #6 – Separation at Threshold of Elevator at Second Level

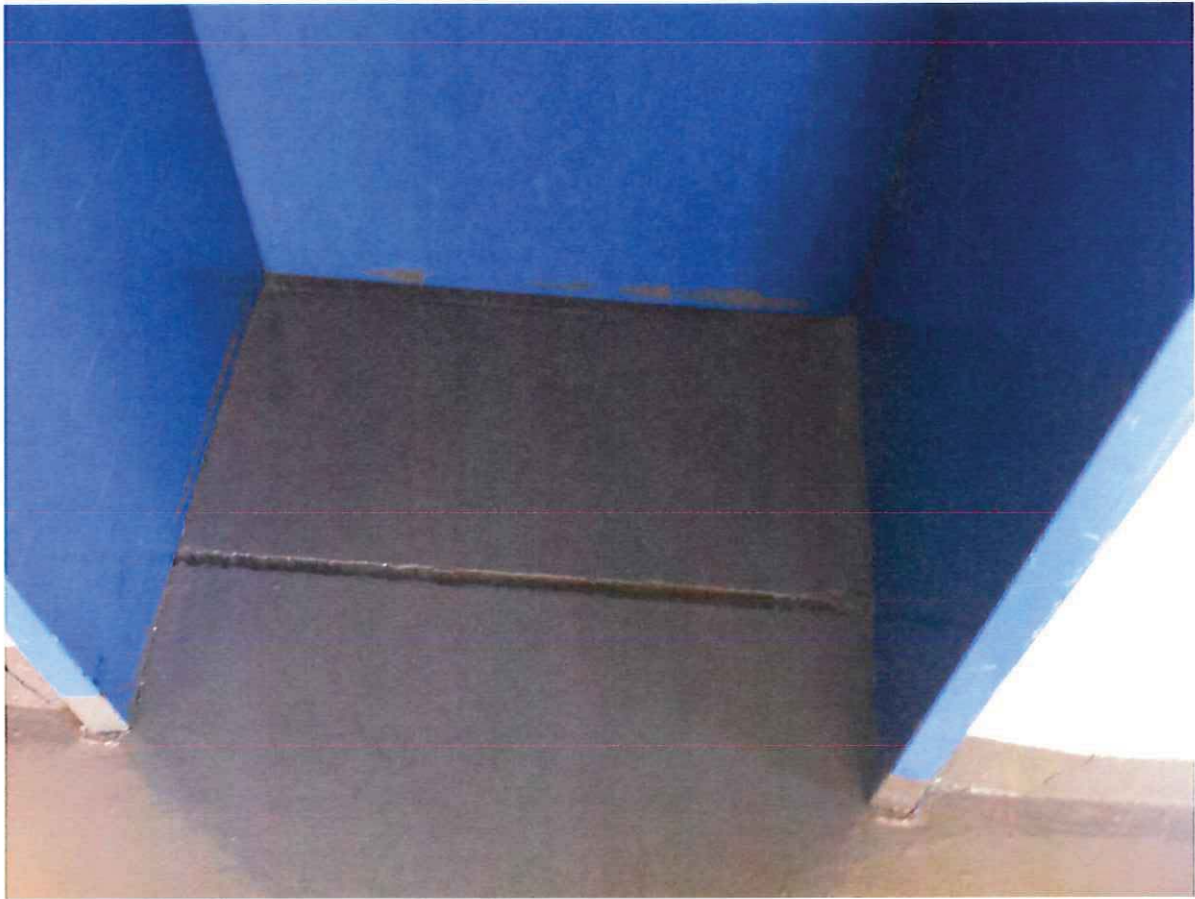
Picture #7 – Separation at Threshold of Elevator at Third Level

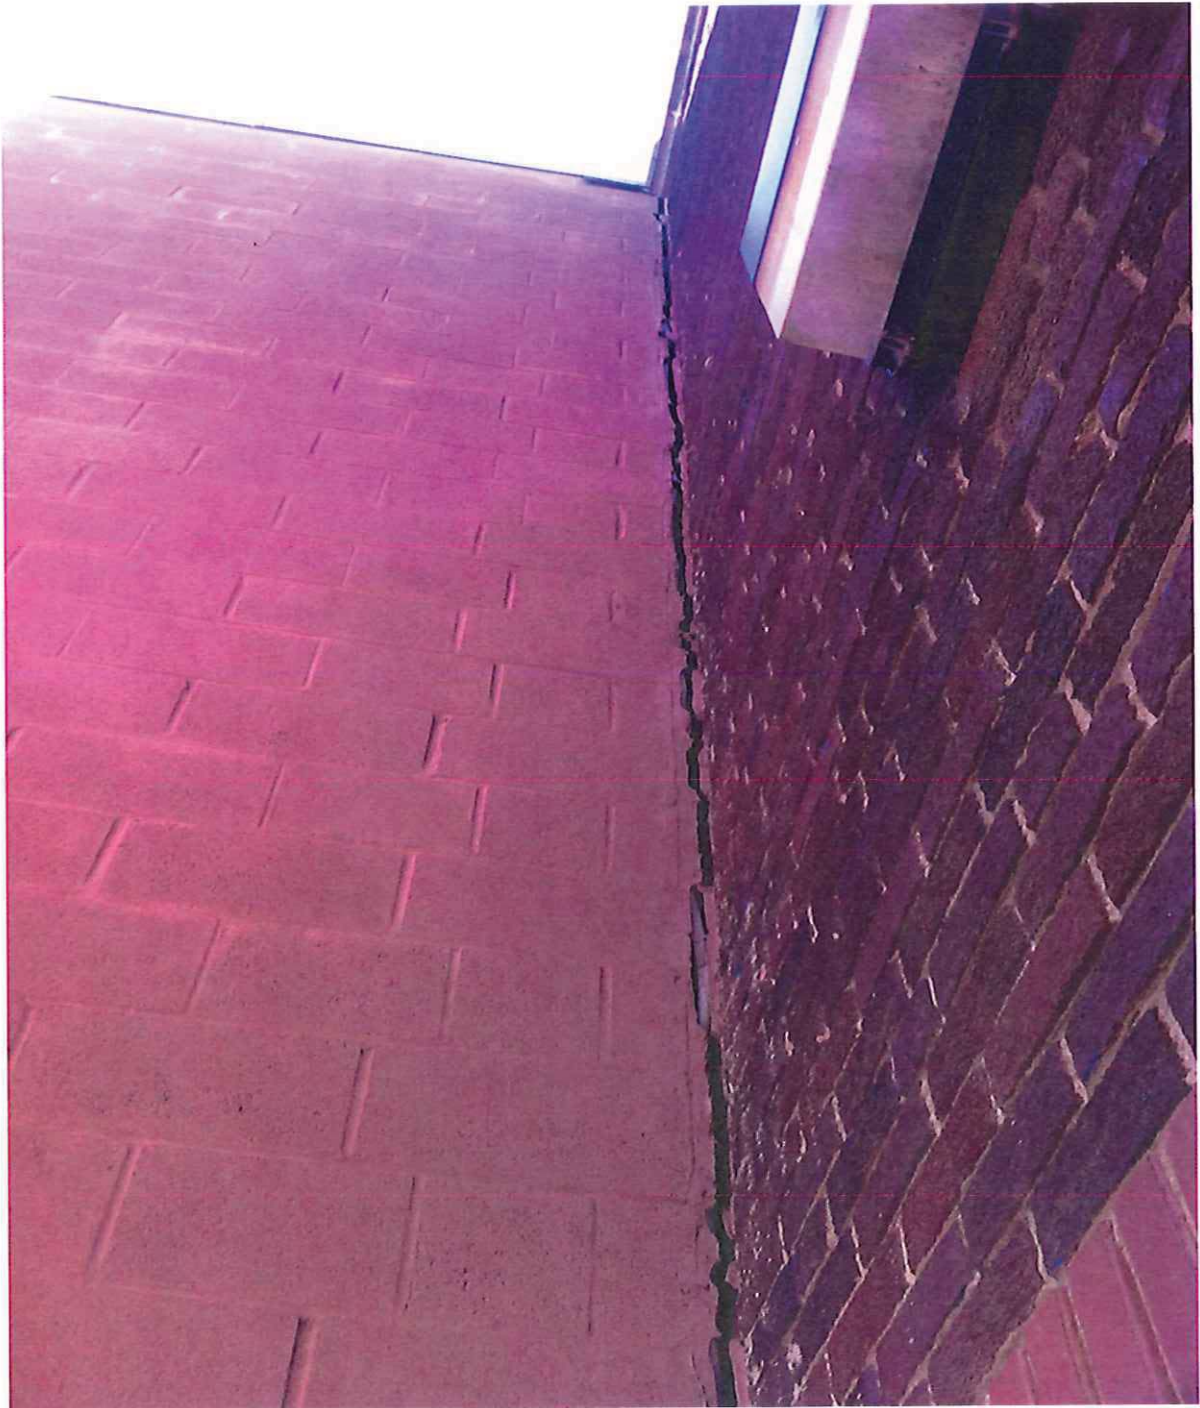
Picture #8 – Separation of Elevator Shaft From Main Building

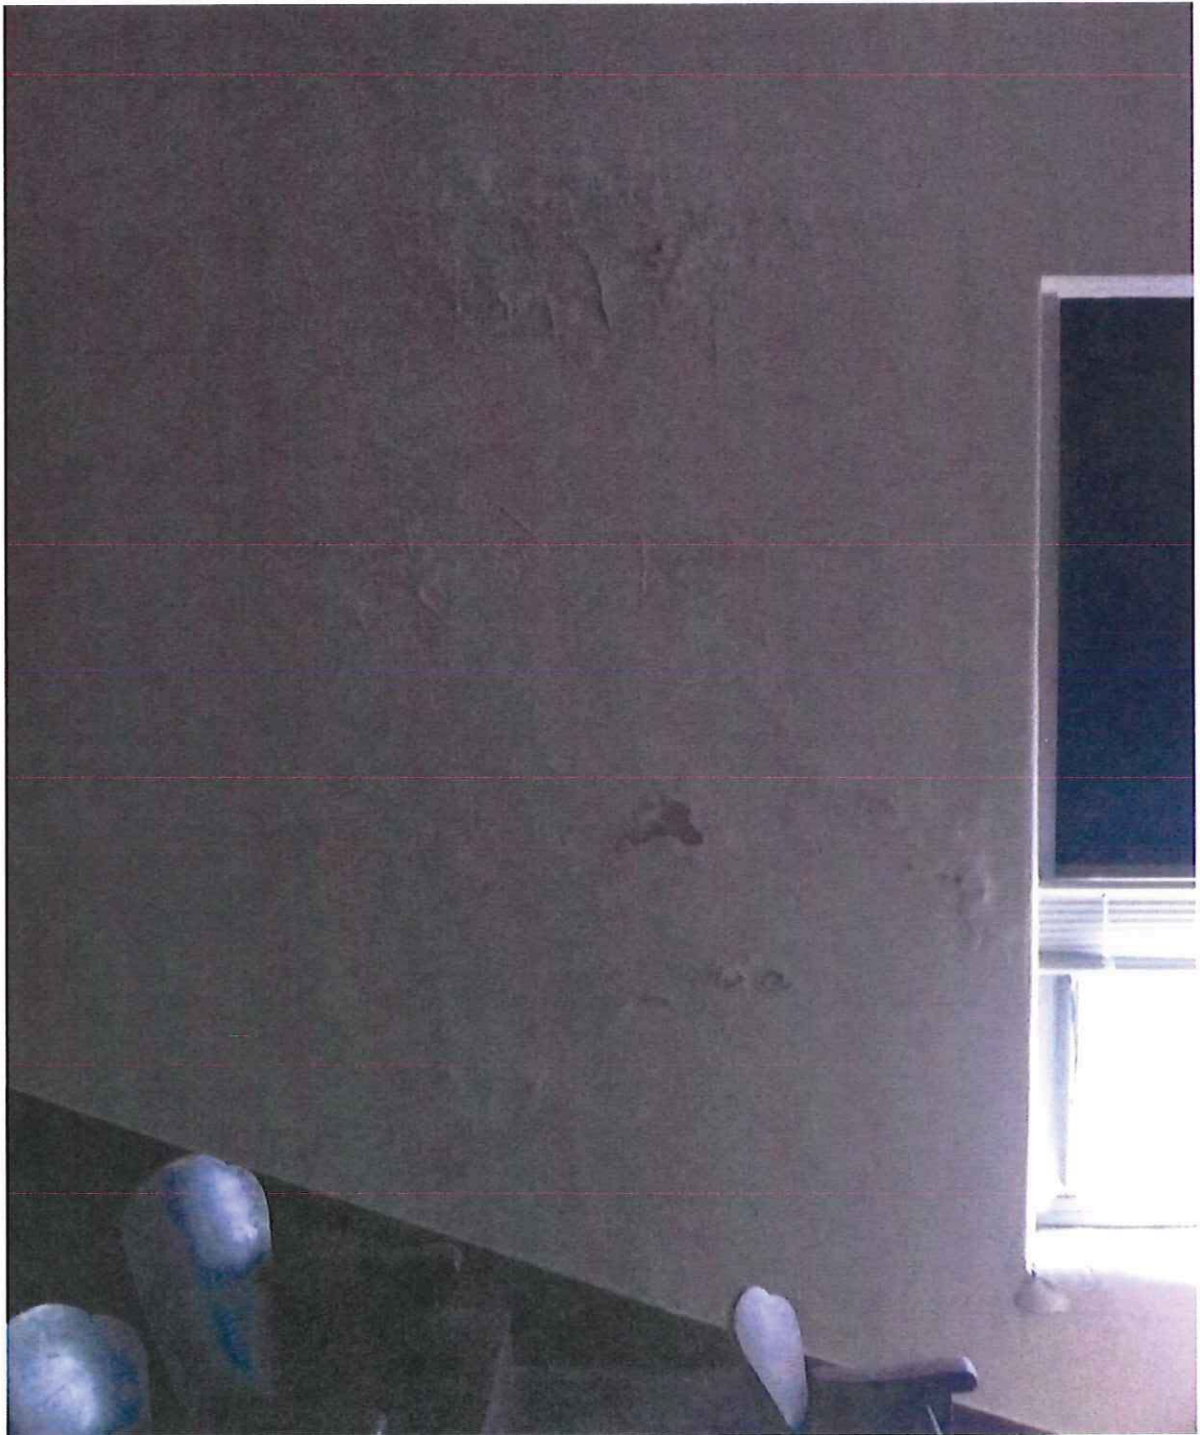
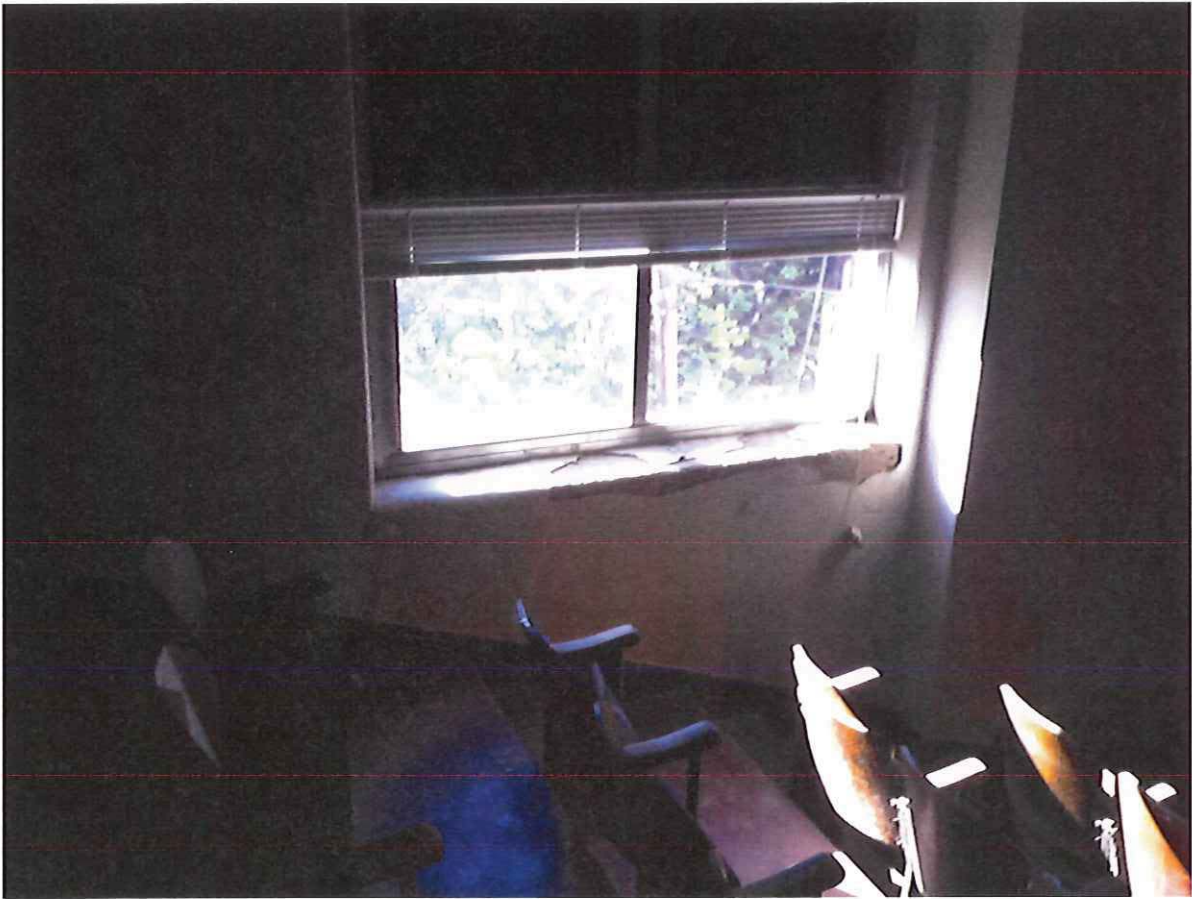
Water infiltration has damaged the plaster around one of the windows in the upper level of the auditorium. Pictures 9 and 10.

Picture #9 – Water Damage to Plaster at Upper Level of Auditorium

Picture #10 – Water Damage to Plaster at Upper Level of Auditorium

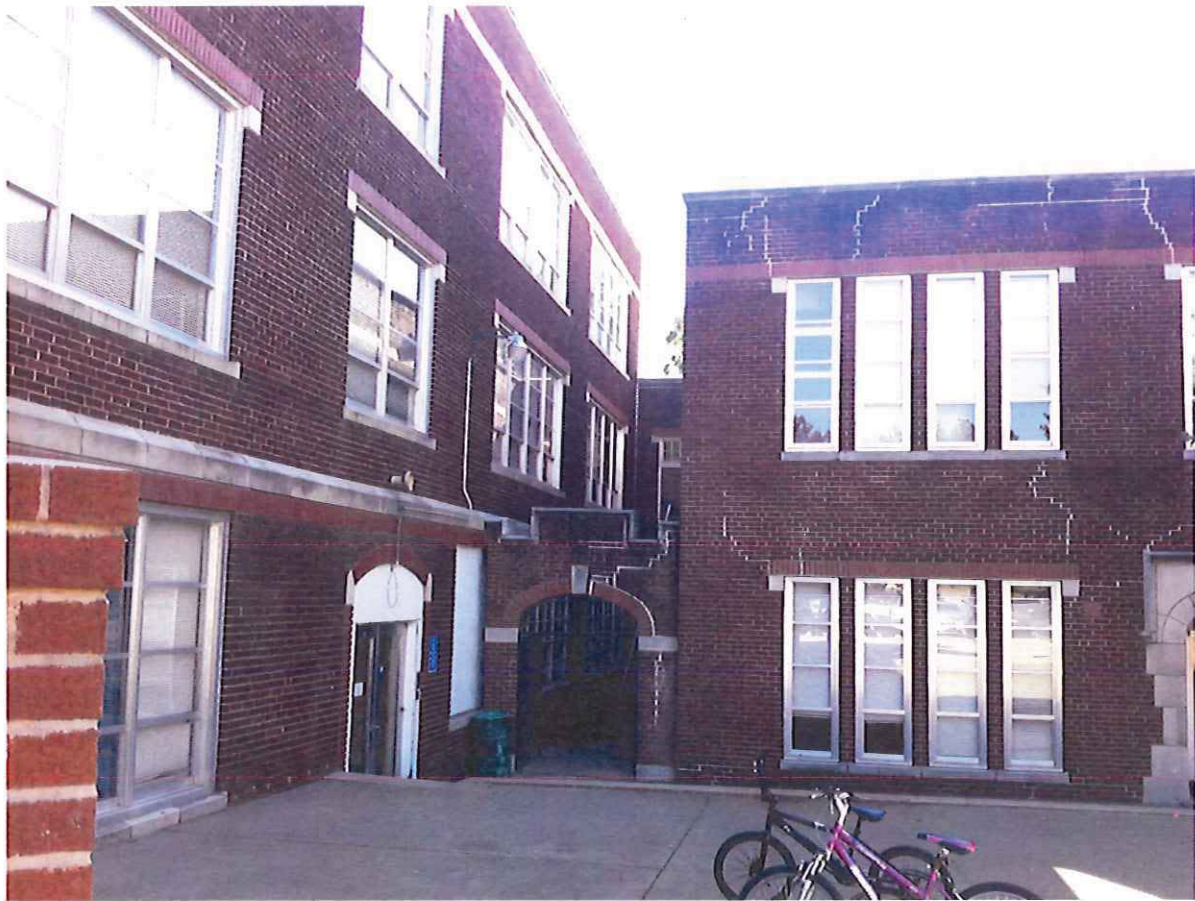
Picture #11 – Repointed Mortar Joints
