# JR. HIGH RENOVATION FACILITY ANALYSIS

## GUTHRIE PUBLIC SCHOOLS

November 19, 2013

Building Name: Guthrie Jr. High

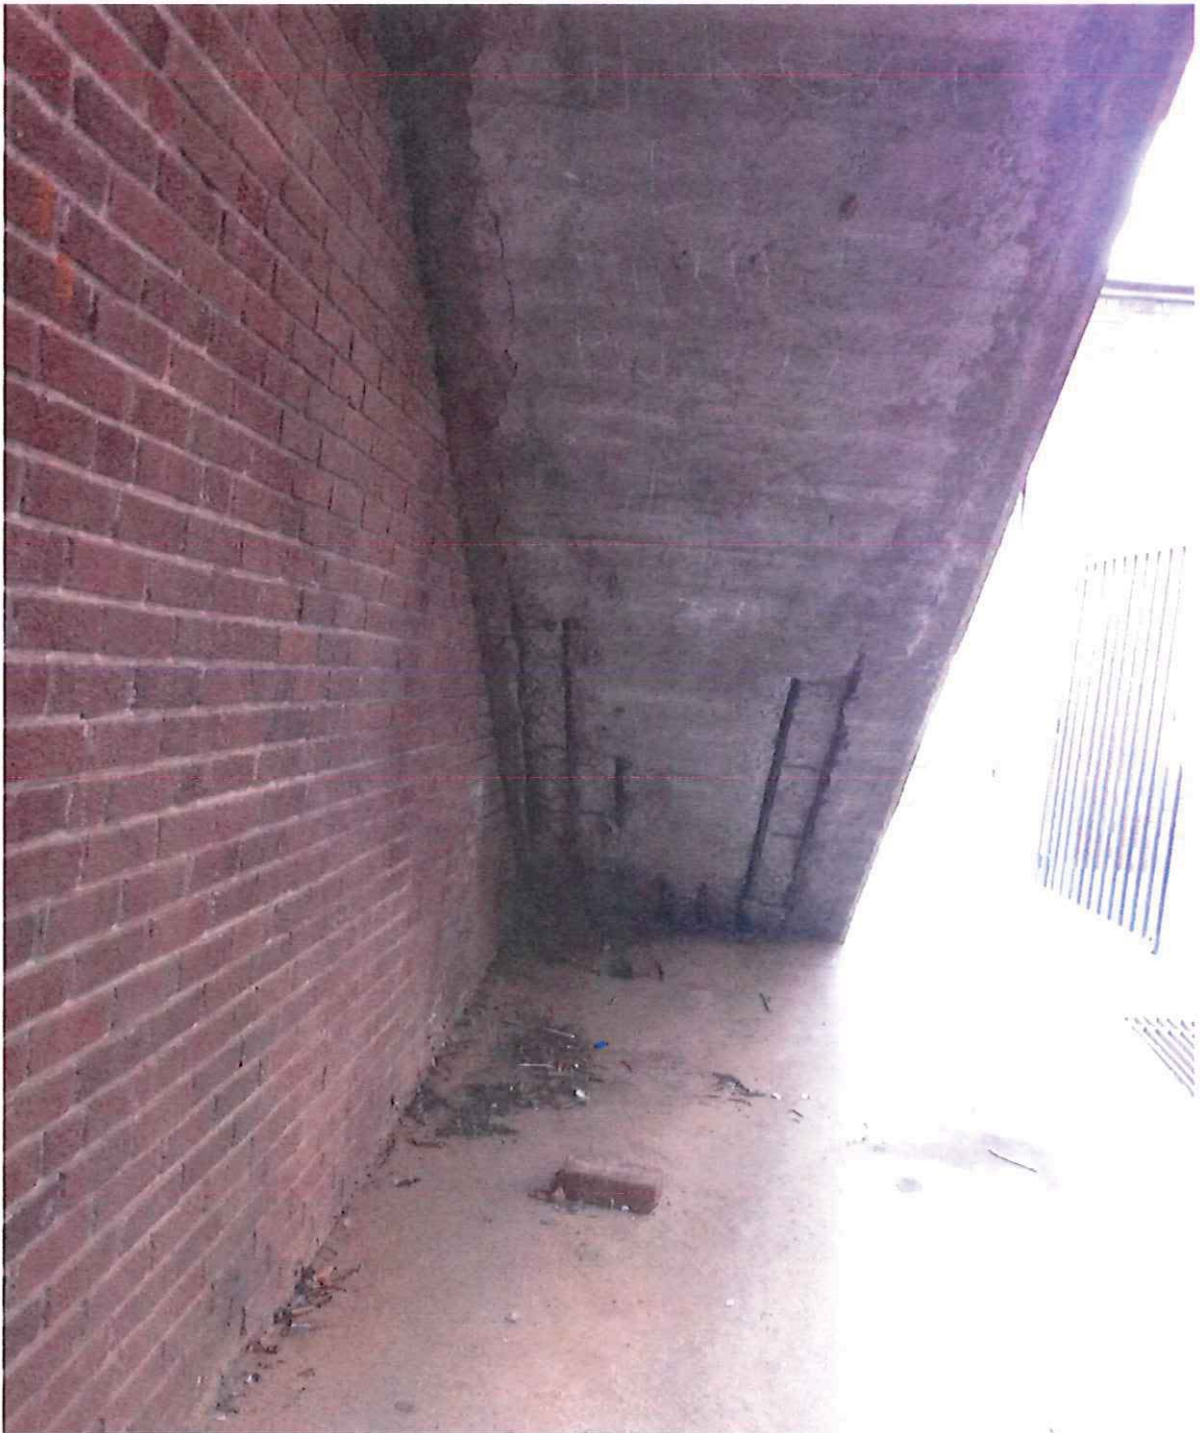
Reinforcing for the exterior stair between the original building and the 1936 addition is exposed and rusting. Picture #12.

Picture #12 – Exposed Reinforcing on Bottom Surface of Exterior Stair

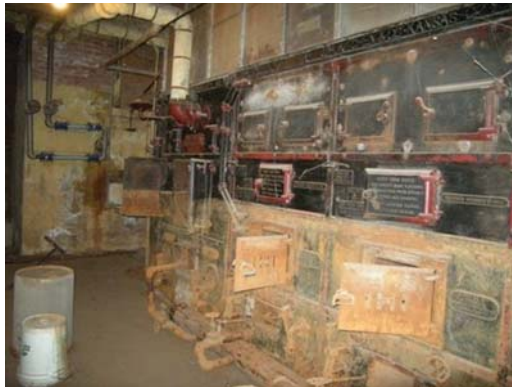
The existing basement has original boiler and air handler abandoned in place. The sump pump in this room must be maintained in working condition. There were no working lights at the time of our inspection.

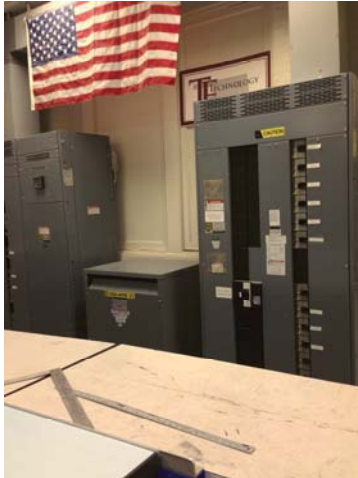
Though fire alarm devices were installed in the 1997 renovation, they were not installed in all the classrooms as is the current requirement. The auditorium will require voice evac and the existing fire alarm system will have to be assessed whether it can handle the expansion of all the new visual devices and the voice evac.

Provide a new larger transformer to feed the existing 800 amp 208 volt distribution panel SDP. This transformer and panel SDP can be fed from the existing 480 volt MDP by providing a new breaker in the existing MDP. Provide new receptacles and isolated ground panels for all computer circuits desired within the existing classrooms and throughout the building. Provide power as required for all mechanical equipment modifications mentioned above and also provide a GFCI service receptacle within 25 feet of all equipment. Provide all required emergency lighting. Expand or replace the existing fire alarm system to handle all the additional devices required.
