# JR. HIGH RENOVATION FACILITY ANALYSIS

## GUTHRIE PUBLIC SCHOOLS

November 19, 2013

Building Name: Guthrie Jr. High

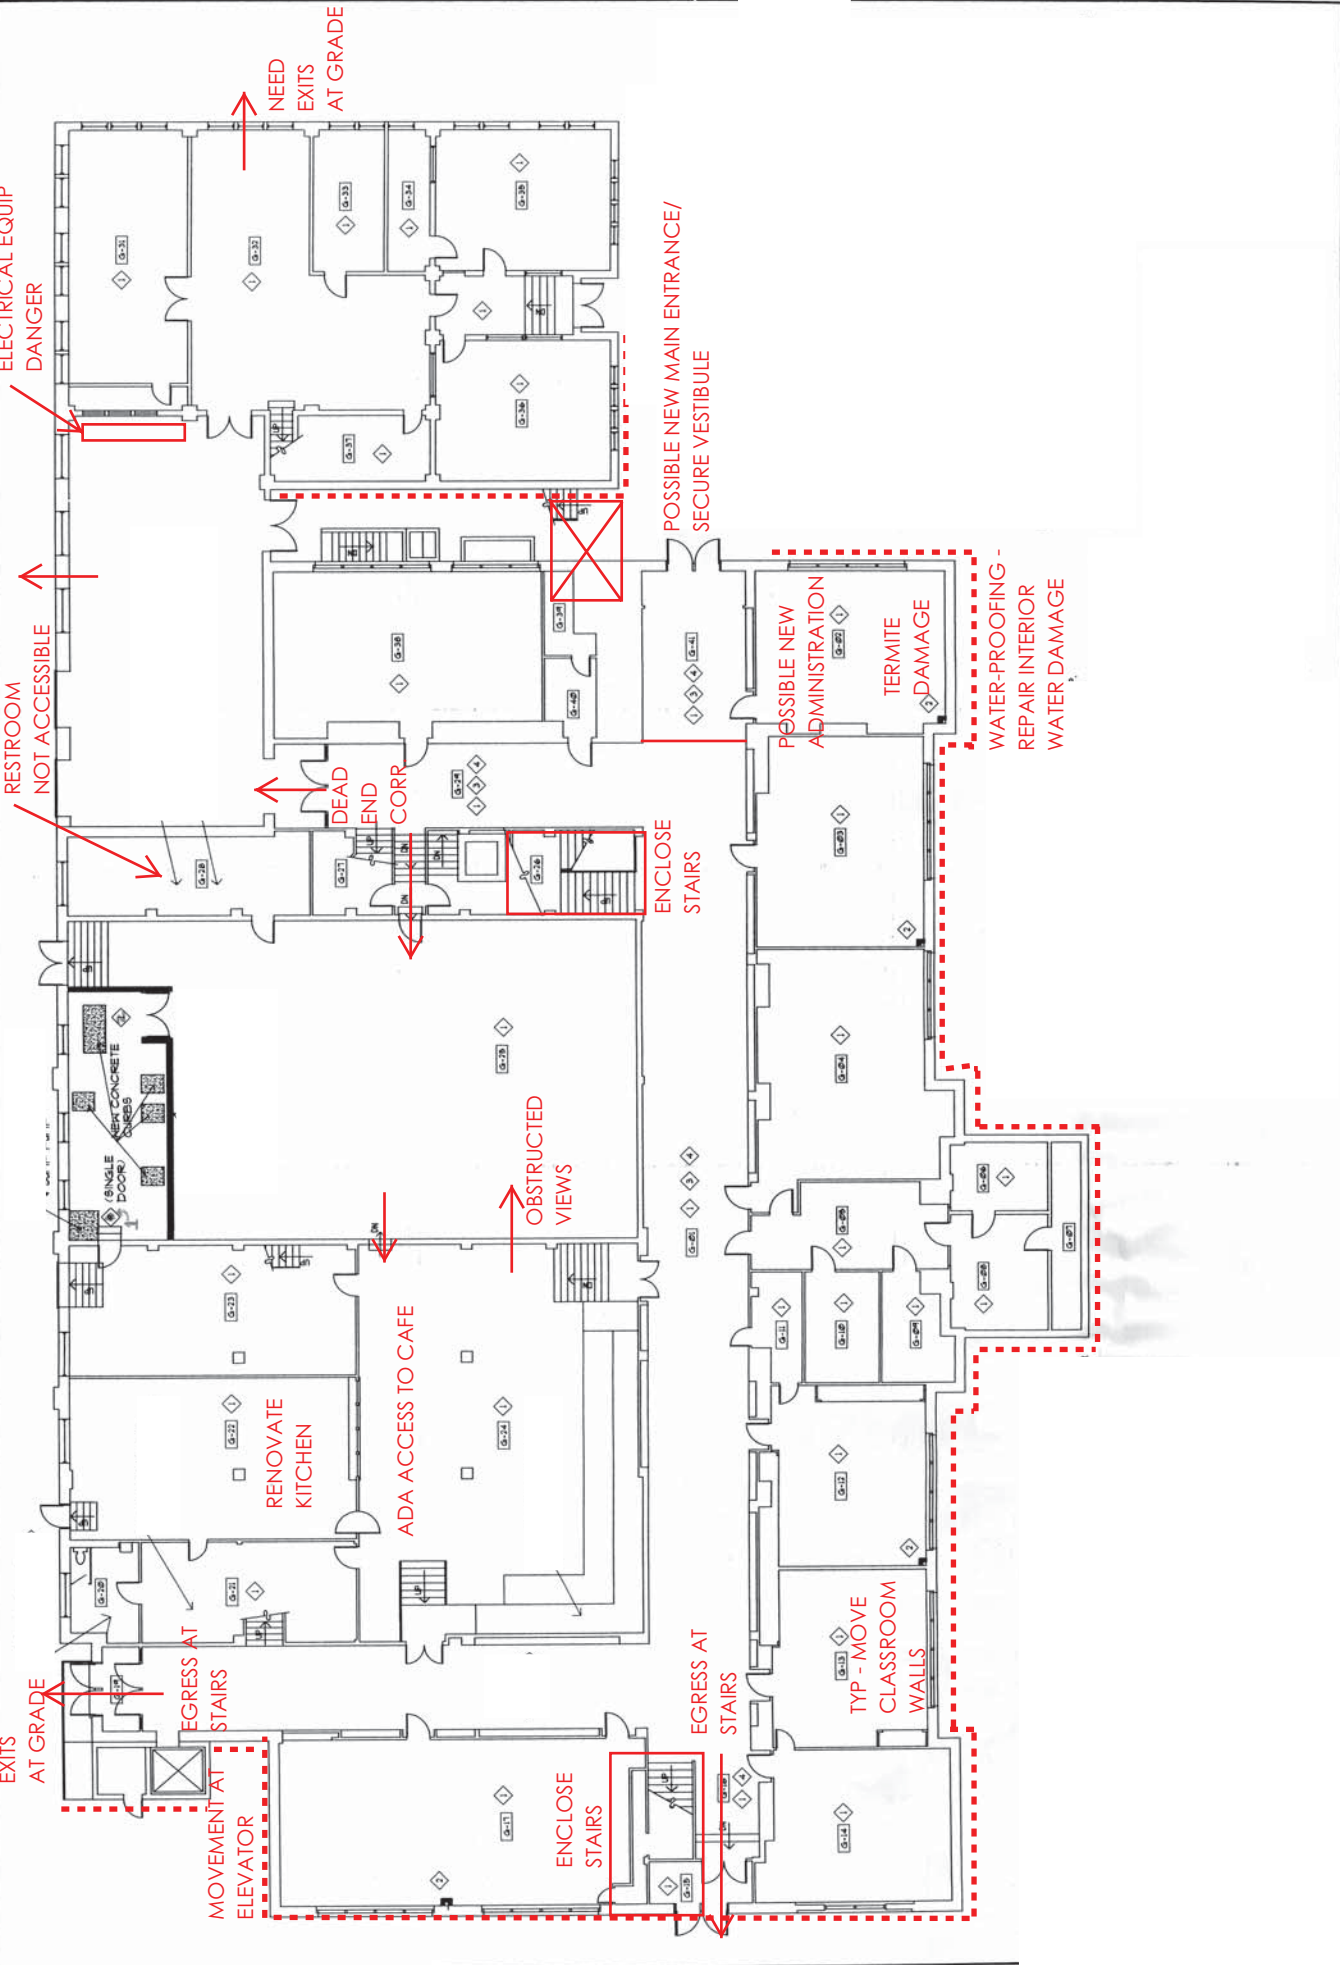
TERMITE DAMAGE

WATER-PROOFING - REPAIR INTERIOR WATER DAMAGE

NEED EXITS AT GRADE

NEW EXIT  
STAIR TOWER

MOVEMENT AT  
ELEVATOR

ADA RAMP TO ENTRY

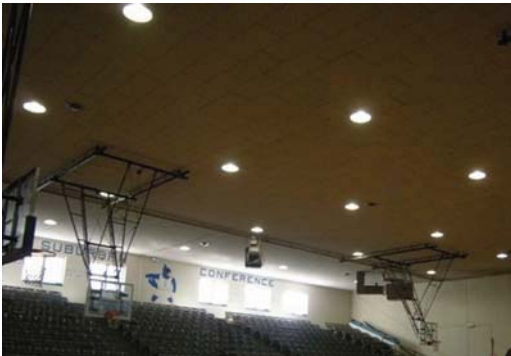
The existing Gym is heated only. There are six heaters, three on each side of the Gym. Only two of the six heaters are working. The lockers located below the Gym are heated only as well.

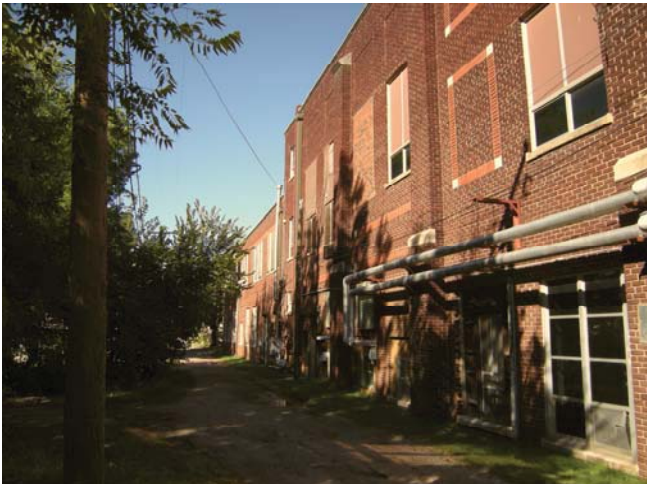
The existing building is a three story building originally built in 1924 and modified throughout the years with the largest modification and upgrade being performed in 1997. The electrical distribution system was reworked at that time. A new 480Y/277v Square D main panel was installed along with a Square D 150kva step down transformer and 800 amp 208/120v distribution panel SDP all located on the first level. The new MDP serves the RTUs, chiller, step down transformer and various panels throughout the building. These panels were also replaced during the 1997 upgrade. The service enters the building from the transmission lines along the alley behind the building. The telephone pedestal is also located across the alley. The electric service comes in underground from a dip pole somewhat obscured by trees in the photo below:
